The Ledge

Structural Glass Observation Boxes at the Willis (Sears) Tower

John Kooymans*, P. Eng.
MTE Consultants Inc.
3115 Harvester Road
Burlington, Ontario, Canada

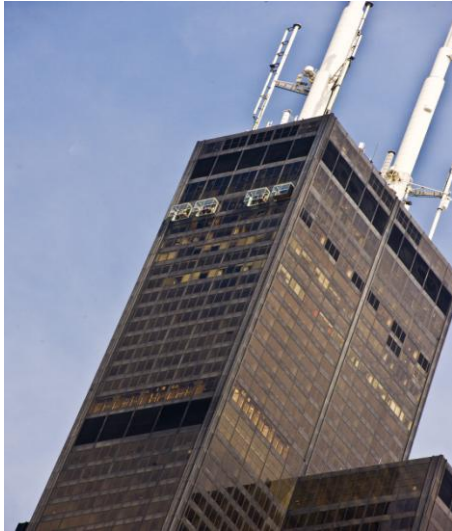
Figure 1: Observation Boxes at the 103rd Floor

The four glass observation boxes (now referred to as “The Ledge”) have a footprint approximately 1.3 m x 3.2 m in plan and are close to 3.6 m high. The walls, roof, and floor are all fabricated from laminated tempered glass. Our goal was to create this glass structure with as little structural steel or aluminum elements as possible, and to ensure that any support structure required was above the viewing lines of the patrons. As the lead engineer for the project, this challenge was met with excitement, but most of all, with a sheer determination to create something spectacular for an iconic landmark building. Despite the high wind loads, the lateral drift of the building, the requirement for moving the boxes in and out, the thermal stresses they would be exposed to, there was no way that we would accept a steel frame at the floor level and corners of the walls to support the glass and its patrons. Maximizing the “fear factor” effect of the attraction while engineering a safe structure that could obtain a building permit from a conservative city made for a very interesting project that had budgets and schedules to adhere to like any other project.

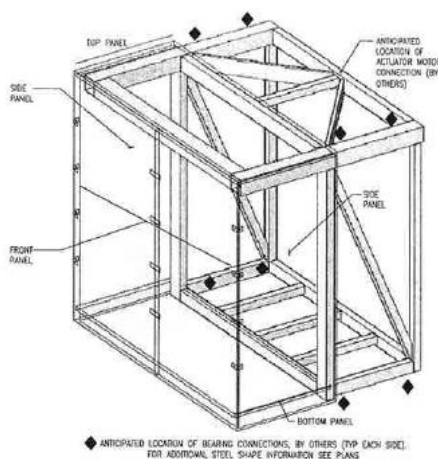
Figure 2: Isometric view of Steel Frame and Glass

It was decided early in the design phase to create a stiff steel braced structure that would be hung from the ceiling structure of the 103rd floor observation deck level. The only portion of the steel frame that would be exposed and project beyond the existing façade would be a perimeter cantilevered tube section as shown in Figures 2 and 3. The perimeter tube would provide a structure that the glass box could be hung off of, and allow for forced air to be pumped through the section and blow onto the glass to help control condensation. The stiff frame itself allowed for the assembly to be hung off a rail system in the ceiling and be pushed or pulled into position by the linear beam oscillating motor. This ensured that the boxes could be retracted flush to the building face during window washing and also be retracted 1.3 meters into the building for any maintenance on the boxes themselves. This solution meant we could assemble the boxes on the floor with minor hoisting devices and eliminate the need for any external cranes during construction or any other time during the life of the attraction and also ensured we did not have to modify the automated window washing systems already in place on the tower.

The top rails were used to support the weight of the glass boxes. The bottom rails were used to provide added lateral stability. Both rails would be used to lock the glass boxes into predetermined positions along the tracks so that the oscillating motor would not have to withstand high wind force pressures while not in operation. These observation boxes are left extended in the “viewing position” at all times of the year despite any threat of high wind storms. They are only retracted when the west face of the tower is having its windows washed, or if there is any maintenance required to the boxes themselves.

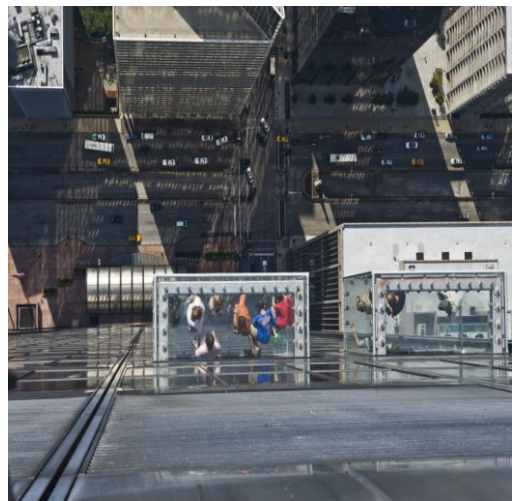
Figure 3: View from Above

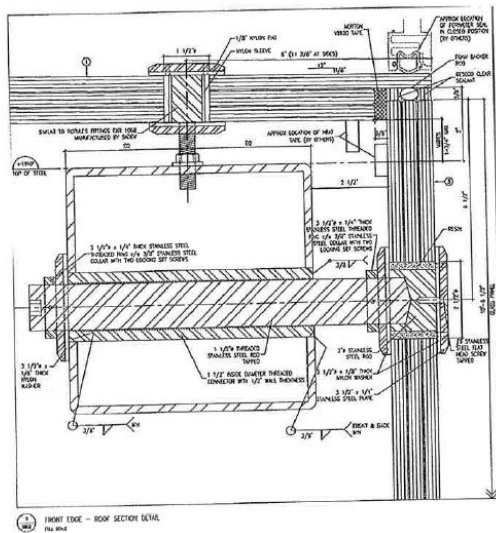
Figure 4: Glass Panel Hanging Detail

In order to minimize the opaque structural elements at the floor and walls, the wall panels were hung off the cantilevered steel frame at the ceiling level of the glass boxes with threaded pins (See Figure 4). The corners and intermediate joints where the different wall panels came into contact with each other were simply stitched together with stainless steel angles and through bolts. The floor, similarly, was stitched to the glass walls creating small local opaque connections that would allow for the transfer of external loads into the hanging glass panels and subsequently, into the steel cantilevered frame (See Figures 5 and 6).

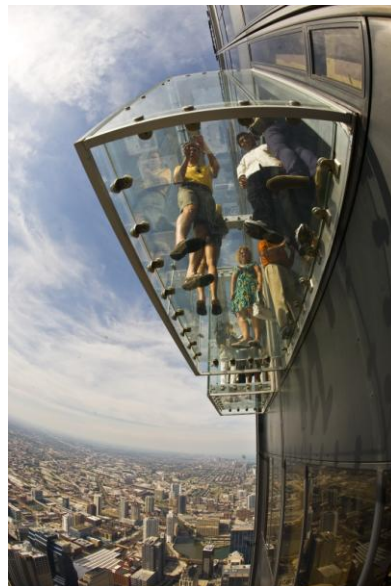
Figure 5: View from Below

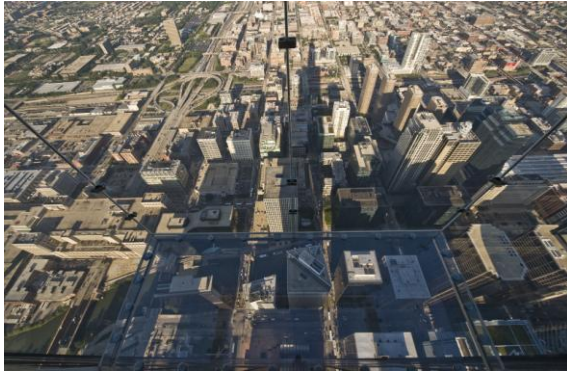
Figure 6: Interior View of Observation Box

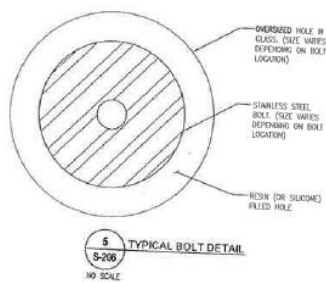
Figure 7: Typical Bolt Detail

All the holes in the glass were oversized to allow for tolerances in fabrication and erection. This also allowed for different support conditions at each hole to ensure thermal movements were incorporated into the design elements and did not create high stress points due to locking the overall system into place. This was achieved by specifying three different types of bolt connection details. Firstly, there was the fixed point connection which required the oversized hole to be filled entirely with a Hilti HY-70 resin ensuring that the through bolt was in full bearing in all directions. The second utilized an oval bushing within the oversized hole so that the resin infill would only lock the bushing into place and still allow movement within the hole in either a horizontal or vertical direction. The third required locking the through bolt into position under very light loads only, but could allow movement in all directions at the same time when subjected to higher wind loads or thermal loads. This was accomplished by filling the oversized hole with silicone (See Figures 7 and 8).

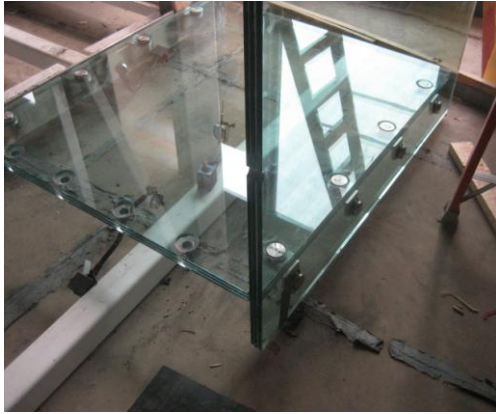
Figure 9: Mock up of Wall and Floor Panel

As with any structural design, human comfort and safety are a necessity. Several issues required our attention. First and foremost, the glass had to be designed with enough redundancy to ensure that any accidental breakage would not result in a total collapse of the system. For this reason, three layers of glass were selected for all the elements. The structure was designed so that only two layers of glass were required to resist the design loads, and only one layer of glass would be able to support the self weight of the structure. In addition to this design decision, the glass floor was constructed using an ionoplastic interlayer (Sentry Glass) captured by the through bolts in the floor which would ensure the stiffness of the tempered floor panel would remain in-tact in the remote possibility that all three structural glass lites failed (See Figures 9, 10 and 11 for post-breakage behaviour). In the end, the glass box elements are all created with three layers of 12 mm tempered low iron, heat-soaked glass. The latter requirement of heat-soaking, naturally helped eliminate the potential for spontaneous breakage due to nickel-sulphide inclusions.

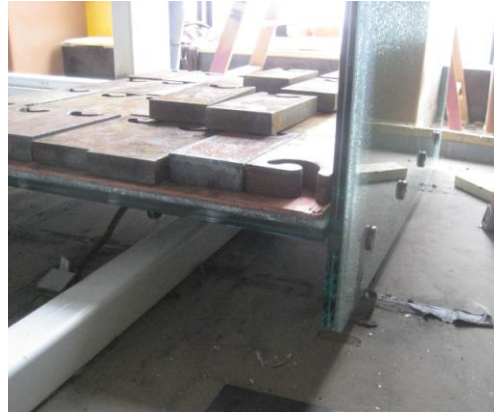
Figure 10: Loaded Mock up

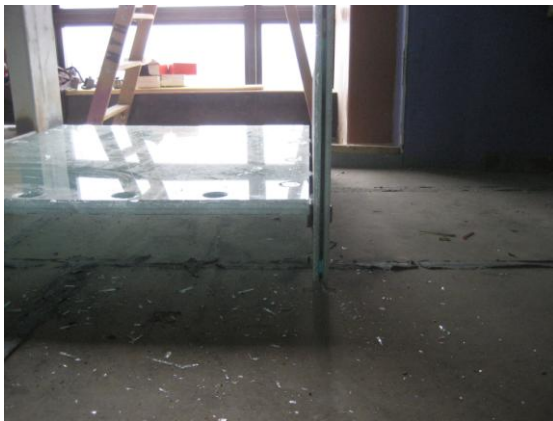
Figure 11: All Floor Panels Broken Retain Stiffness
